DEPARTMENT OF TRANSPORTATION

Office of Structural Materials

Contract #: 04-0120F4Cty: SF/ALA Rte: 80 PM: 13.2/13.9File #: 1.28**WELDING INSPECTION REPORT****Resident Engineer:** Casey, William**Address:** 333 Burma Road**City:** Oakland, CA 94607**Report No:** WIR-028970**Date Inspected:** 12-Jan-2013**Project Name:** SAS Superstructure**OSM Arrival Time:** 700**Prime Contractor:** American Bridge/Fluor Enterprises, a JV**OSM Departure Time:** 1530**Contractor:** American Bridge/Fluor Enterprises, a JV**Location:** Job Site**CWI Name:** Steve Jensen**CWI Present:** Yes No**Inspected CWI report:** Yes No N/A**Rod Oven in Use:** Yes No N/A**Electrode to specification:** Yes No N/A**Weld Procedures Followed:** Yes No N/A**Qualified Welders:** Yes No N/A**Verified Joint Fit-up:** Yes No N/A**Approved Drawings:** Yes No N/A**Approved WPS:** Yes No N/A**Delayed / Cancelled:** Yes No N/A**Bridge No:** 34-0006**Component:** SAS Tower**Summary of Items Observed:**

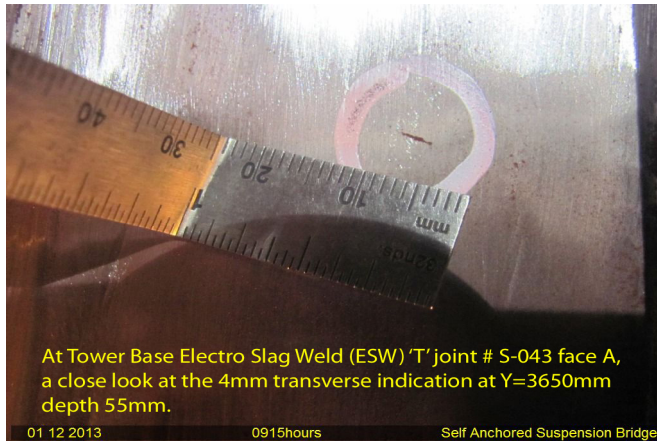
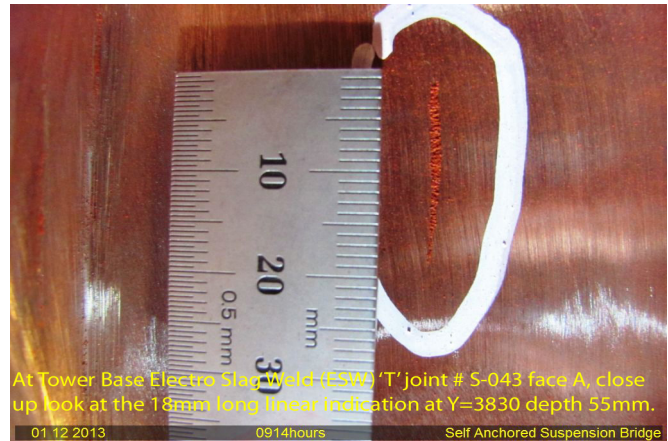
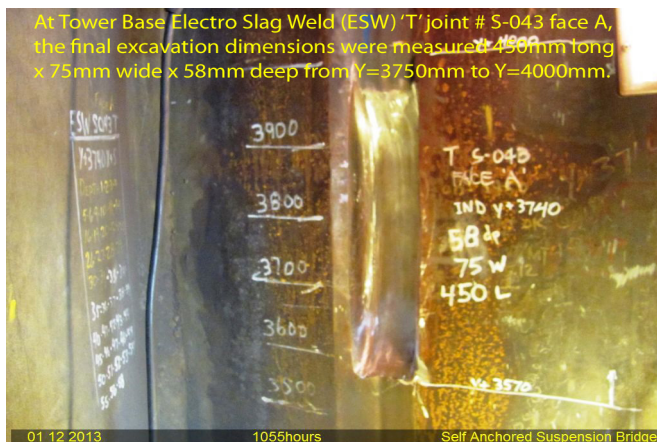
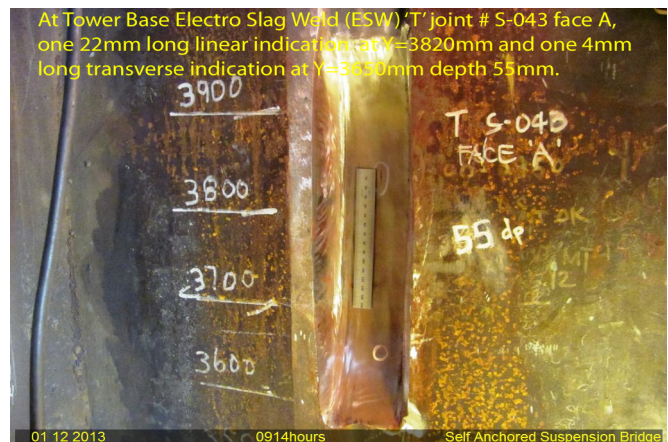
At Tower Base Electro Slag Weld (ESW) 'T' weld joint #S-043 face A, ABF personnel was observed continuing to perform exploratory excavation on welded ESW at location Y=3600 to Y=3950 due to UT detected defects. The ABF personnel have resumed the exploratory excavation from 54mm deep where they left off yesterday. The personnel were noted using only the disc grinder in every 1mm increments of excavation. ABF QC Steve Jensen was observed performing Magnetic Particle Testing (MT) on the following various depths with indications stated below. This QA also performed the same test and noted same result. During the shift, the ABF personnel continued the excavation in 1mm increments using the same method of test and verification up to 55mm with indications as noted below. The shift was completed up to this depth of excavation.

1. 54mm in depth – one 22mm long linear indication at Y=3820mm, X=15mm was noted and three (3) 2 to 5mm transverse indications from Y=3650 to Y=3700mm.

2. 55mm in depth –one 18mm long linear indication at Y=3830mm, X=15mm was noted and one 4mm transverse indication at Y=3650mm

3. 56mm in depth – all linear and transverse indications have been removed. Final measured dimensions after the excavation was measured 450mm long x 75mm wide x 58mm deep from Y=3570 to Y=4000mm.
